WATERBODY MANAGEMENT PLAN SERIES

CHATHAM LAKE

LAKE HISTORY & MANAGEMENT ISSUES

Update – January 2014 – Prepared by
James Seales, Biologist III, District 1
Jeff Sibley, Biologist Manager, District 1

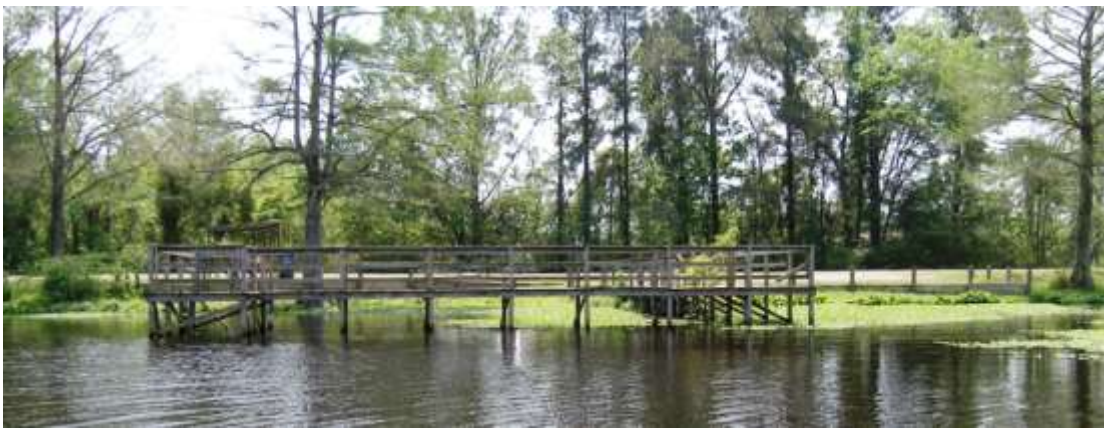
Figure 1. Public fishing pier on Chatham Lake, LA.

There are a few (<5) privately owned piers associated with shoreline properties. One public fishing pier was constructed on the south side of the lake in 2006 (Figure 1).

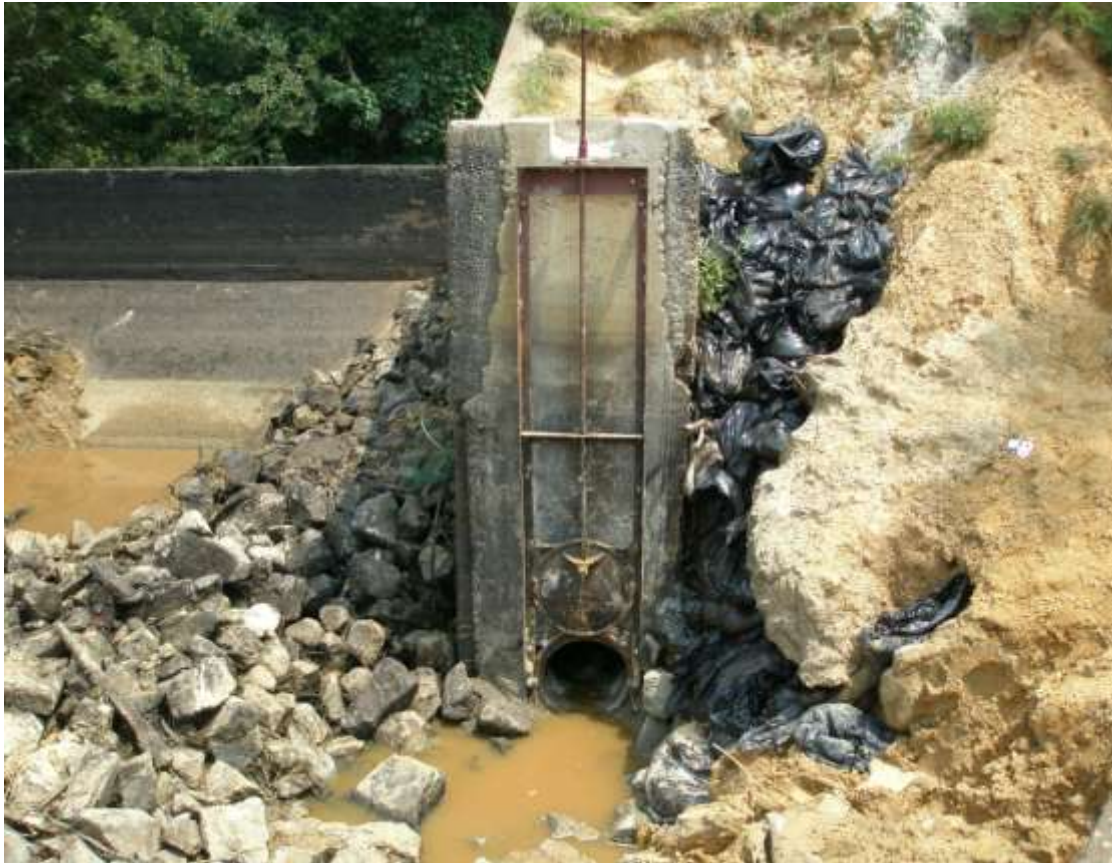
Figure 2. Control structure on Chatham Lake, LA prior to repairs being performed in 2007.

July, 1998 - Letter from Mr. Mike Aghayan, Chief of DOTD Dam Safety, indicated that Chatham Lake Dam required immediate attention. DOTD personnel that inspected the dam were not able to determine the extent of damages. They suspected that the metal sliding gate (approx. 3' X 3') had deteriorated and was leaking (Figure 2). Funding was secured for the repairs by Rep. Jim Fannin through Rural Development Funds in 2006. The spillway gate was replaced in 2007.

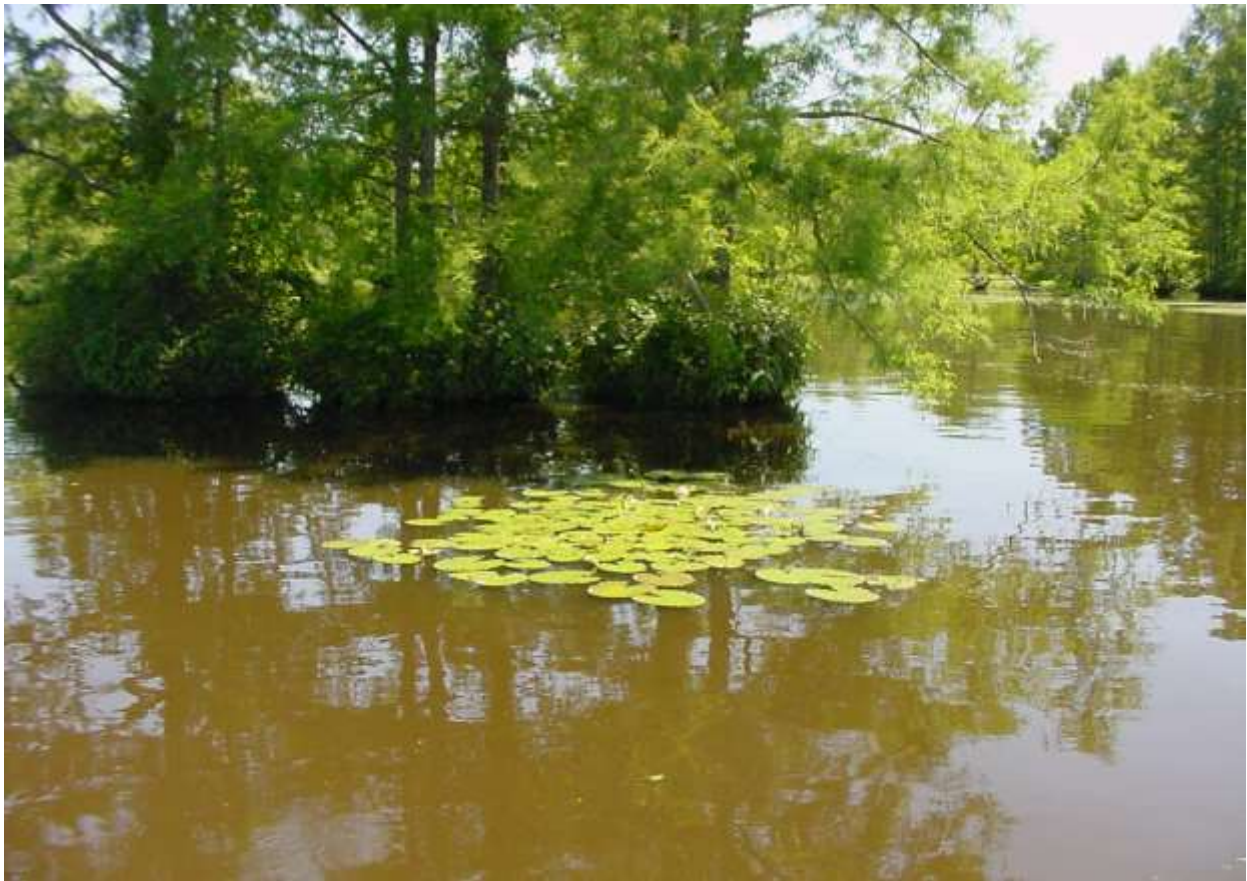
Figure 3. Typical habitat in the upper end of Chatham Lake, LA.

Complex Cover in Chatham Lake consists of aquatic vegetation and bald cypress (*Taxodium distichum*) trees. The upper half of the lake is shallow with scattered cypress trees in the center of the lake and patches of aquatic vegetation that transition to a cypress forest near the headwaters (Figure 3). Much of the timber on the lower half of the lake was cut prior to impoundment. Therefore, complex cover in this part of the lake can only be found in the littoral zone and consists of a fringe of emergent vegetation and cypress trees.
